## **Arkema Facility - Harvey Response**

Crosby, TX

September 2, 2017

Project #109489 Summary

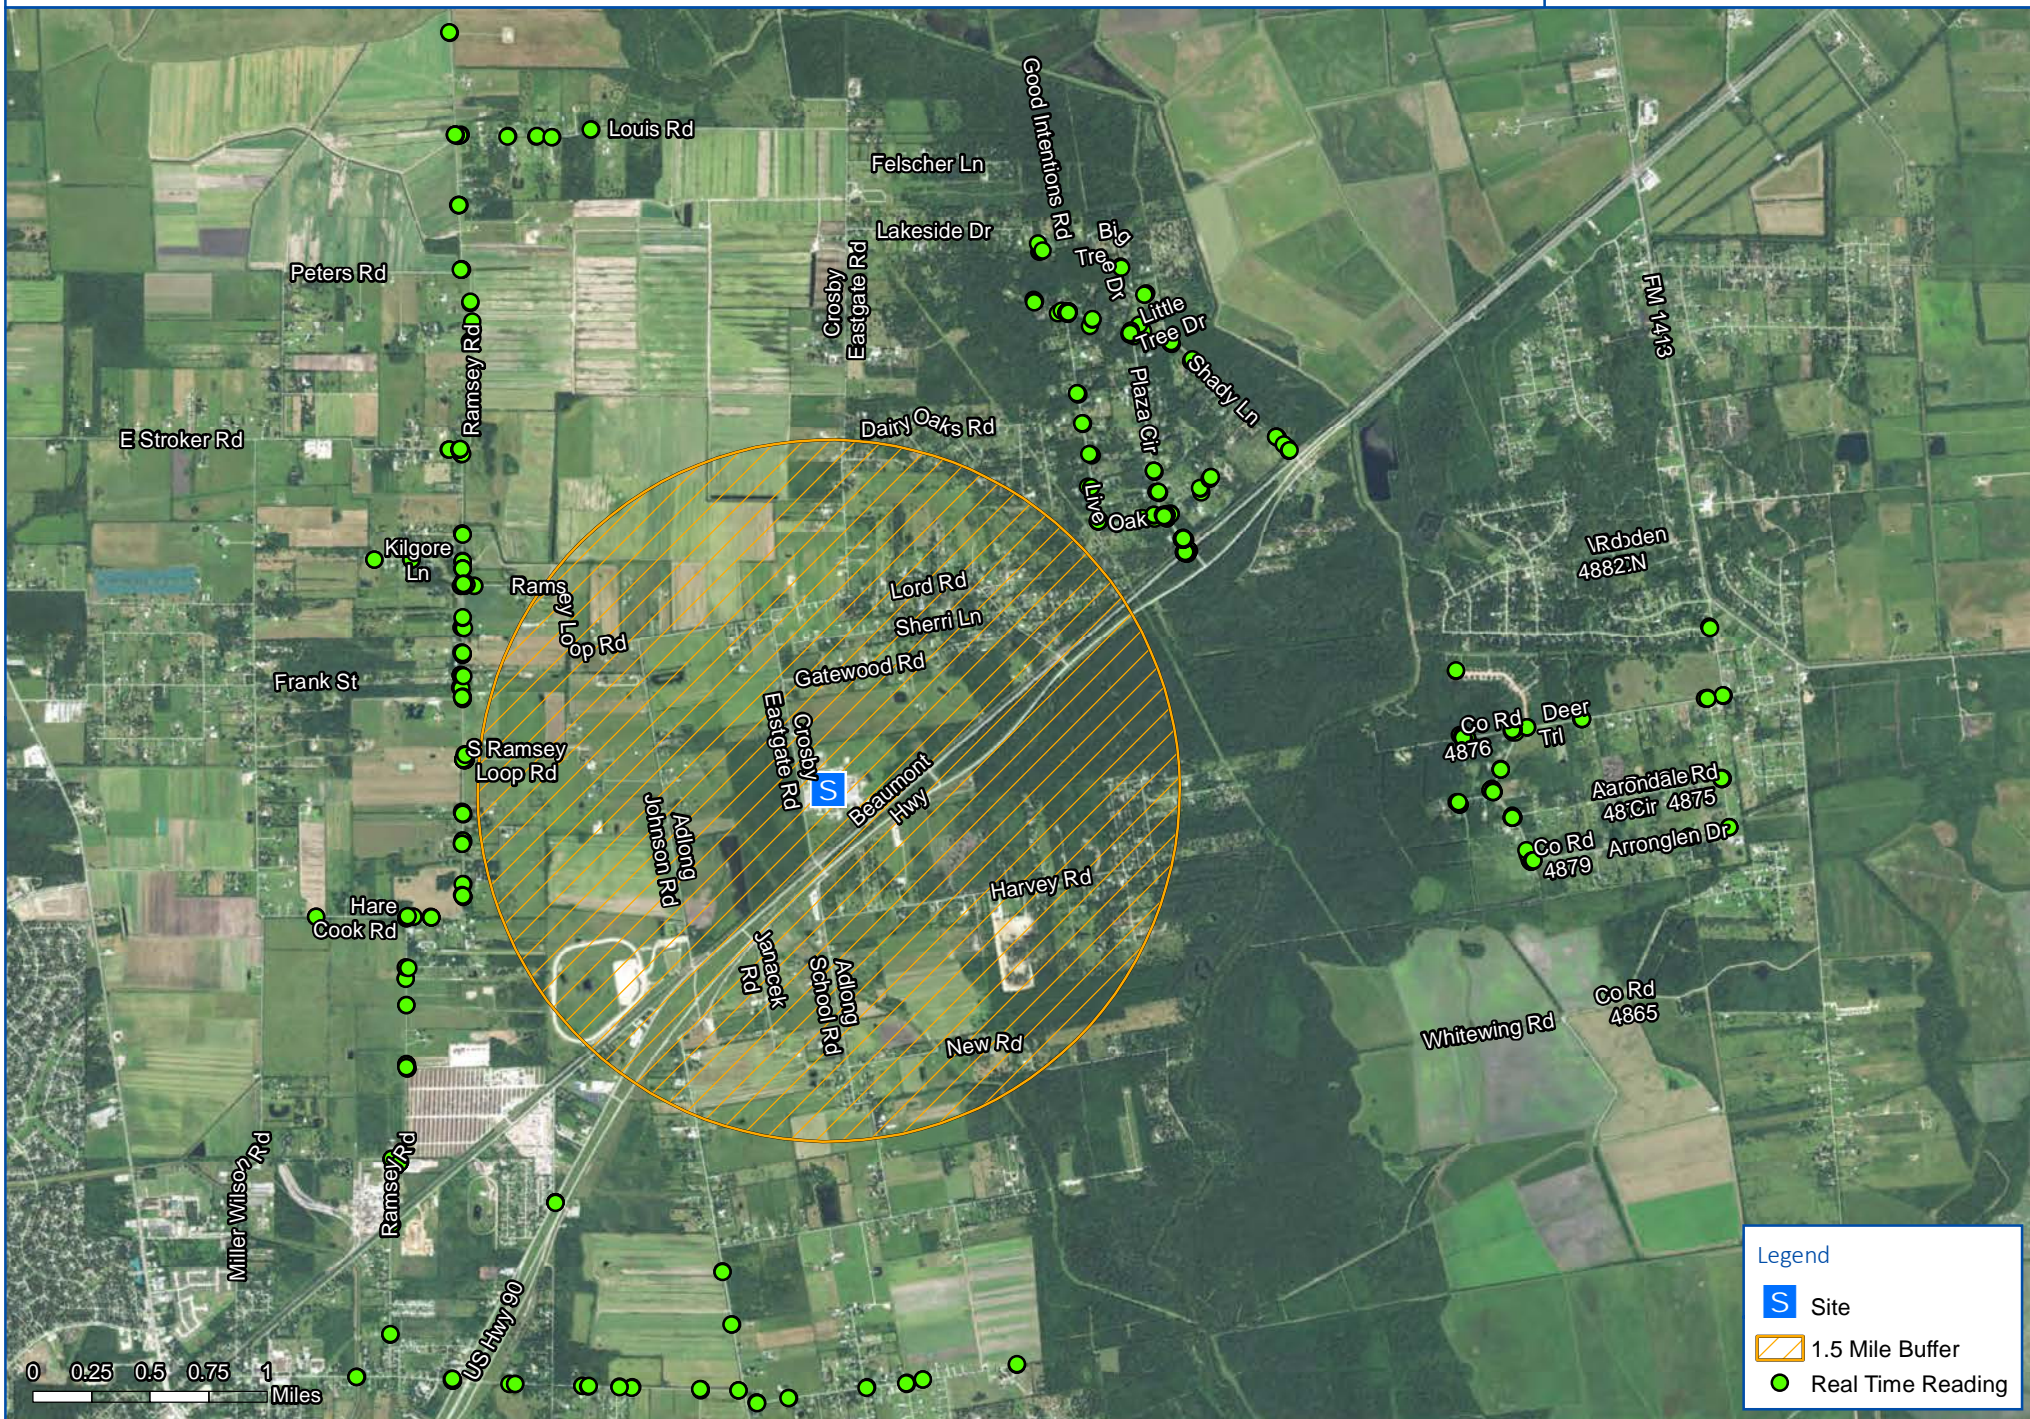
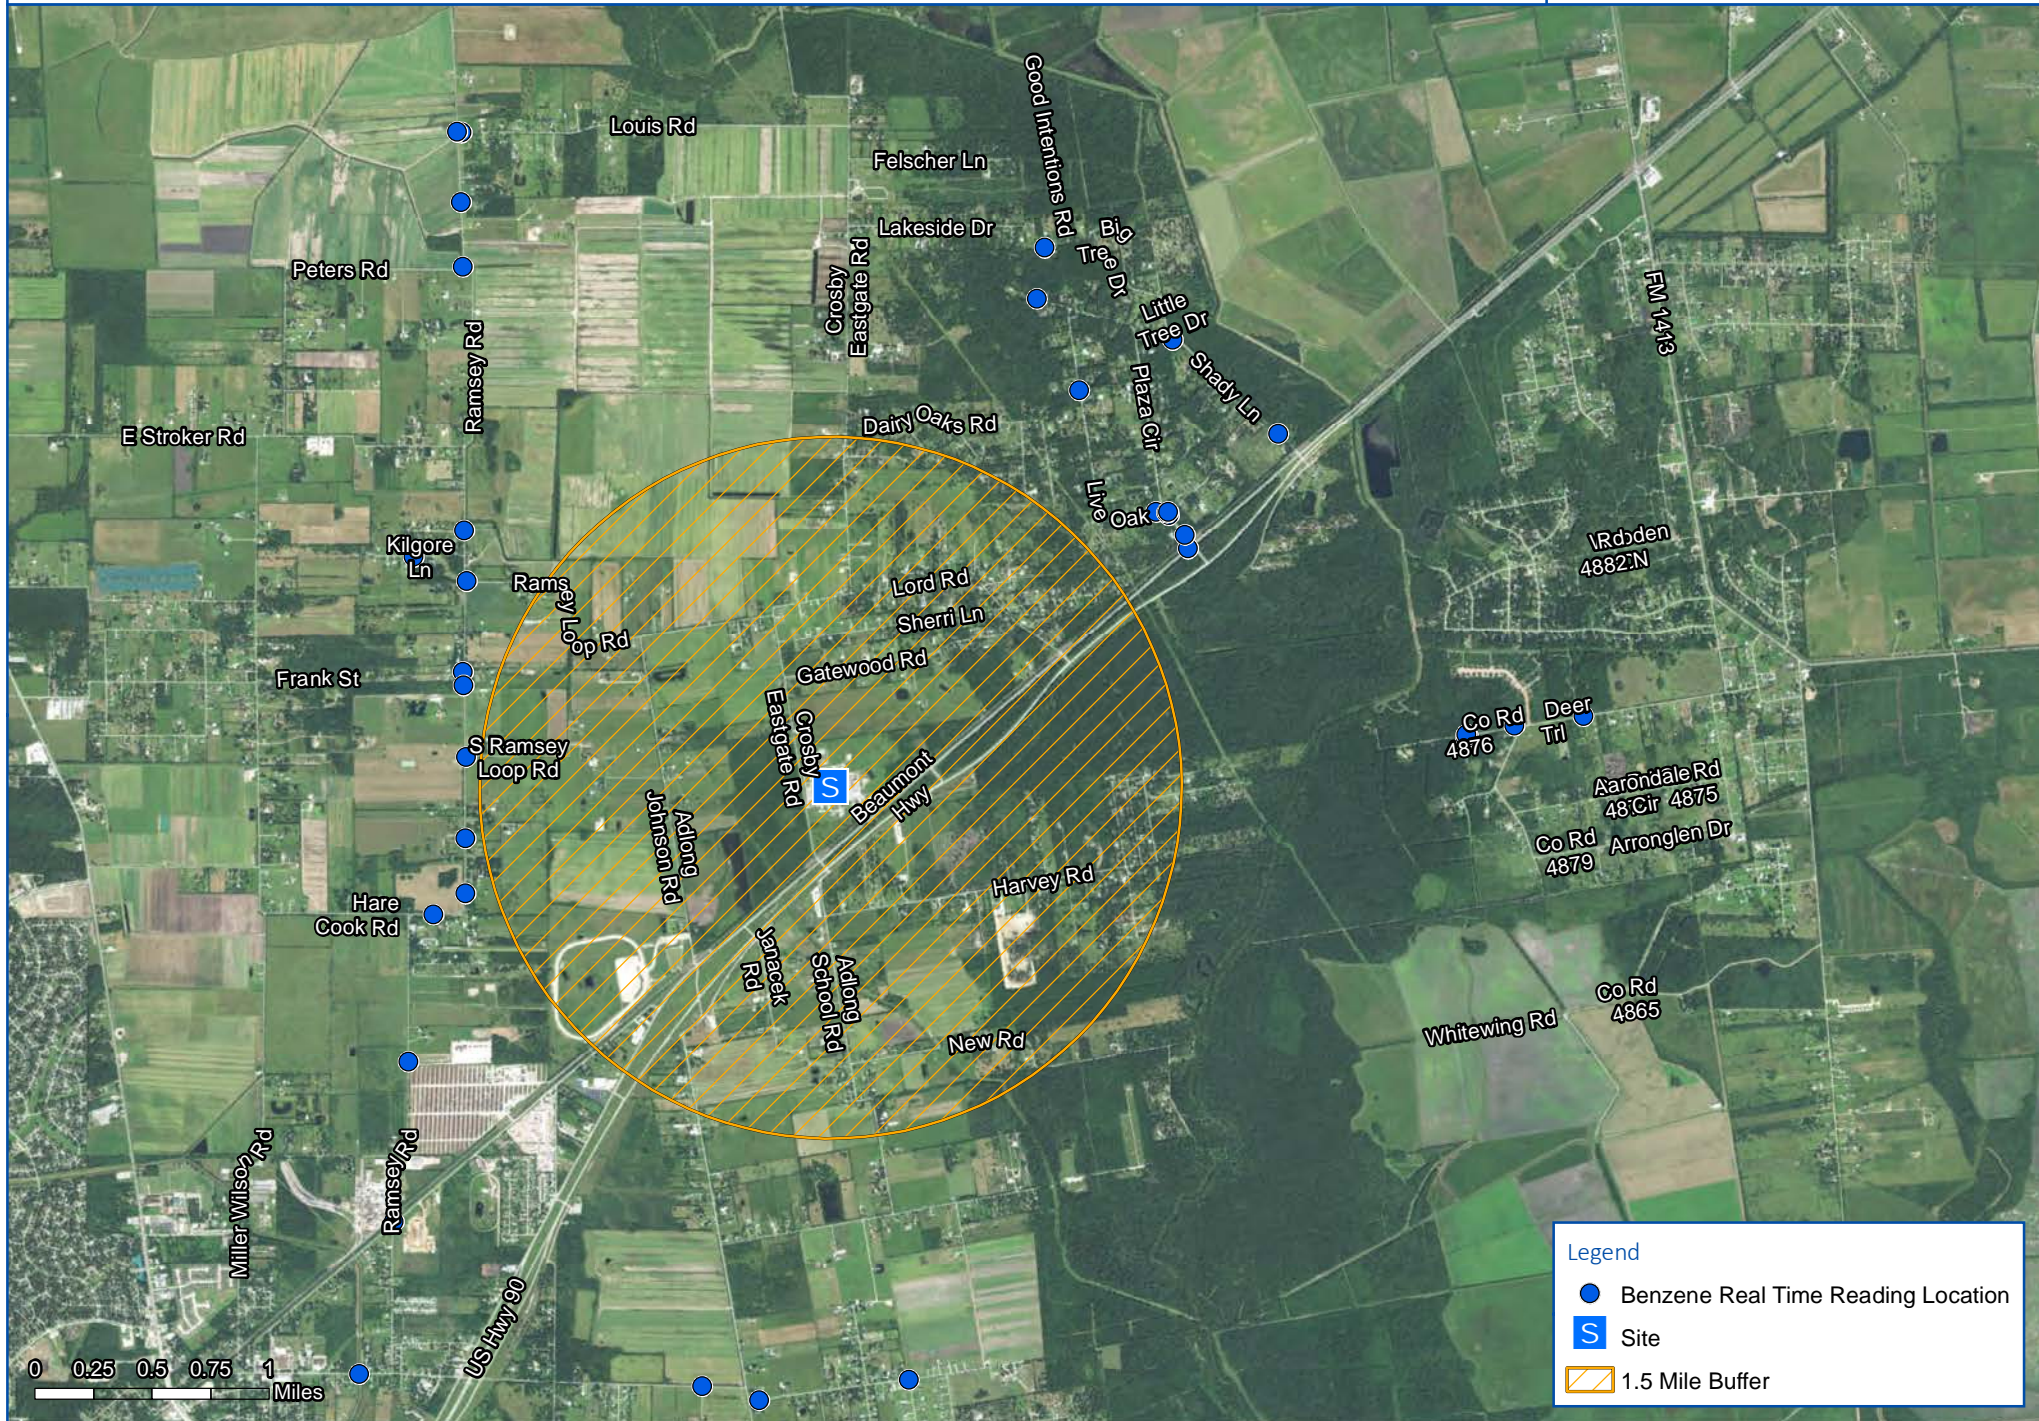
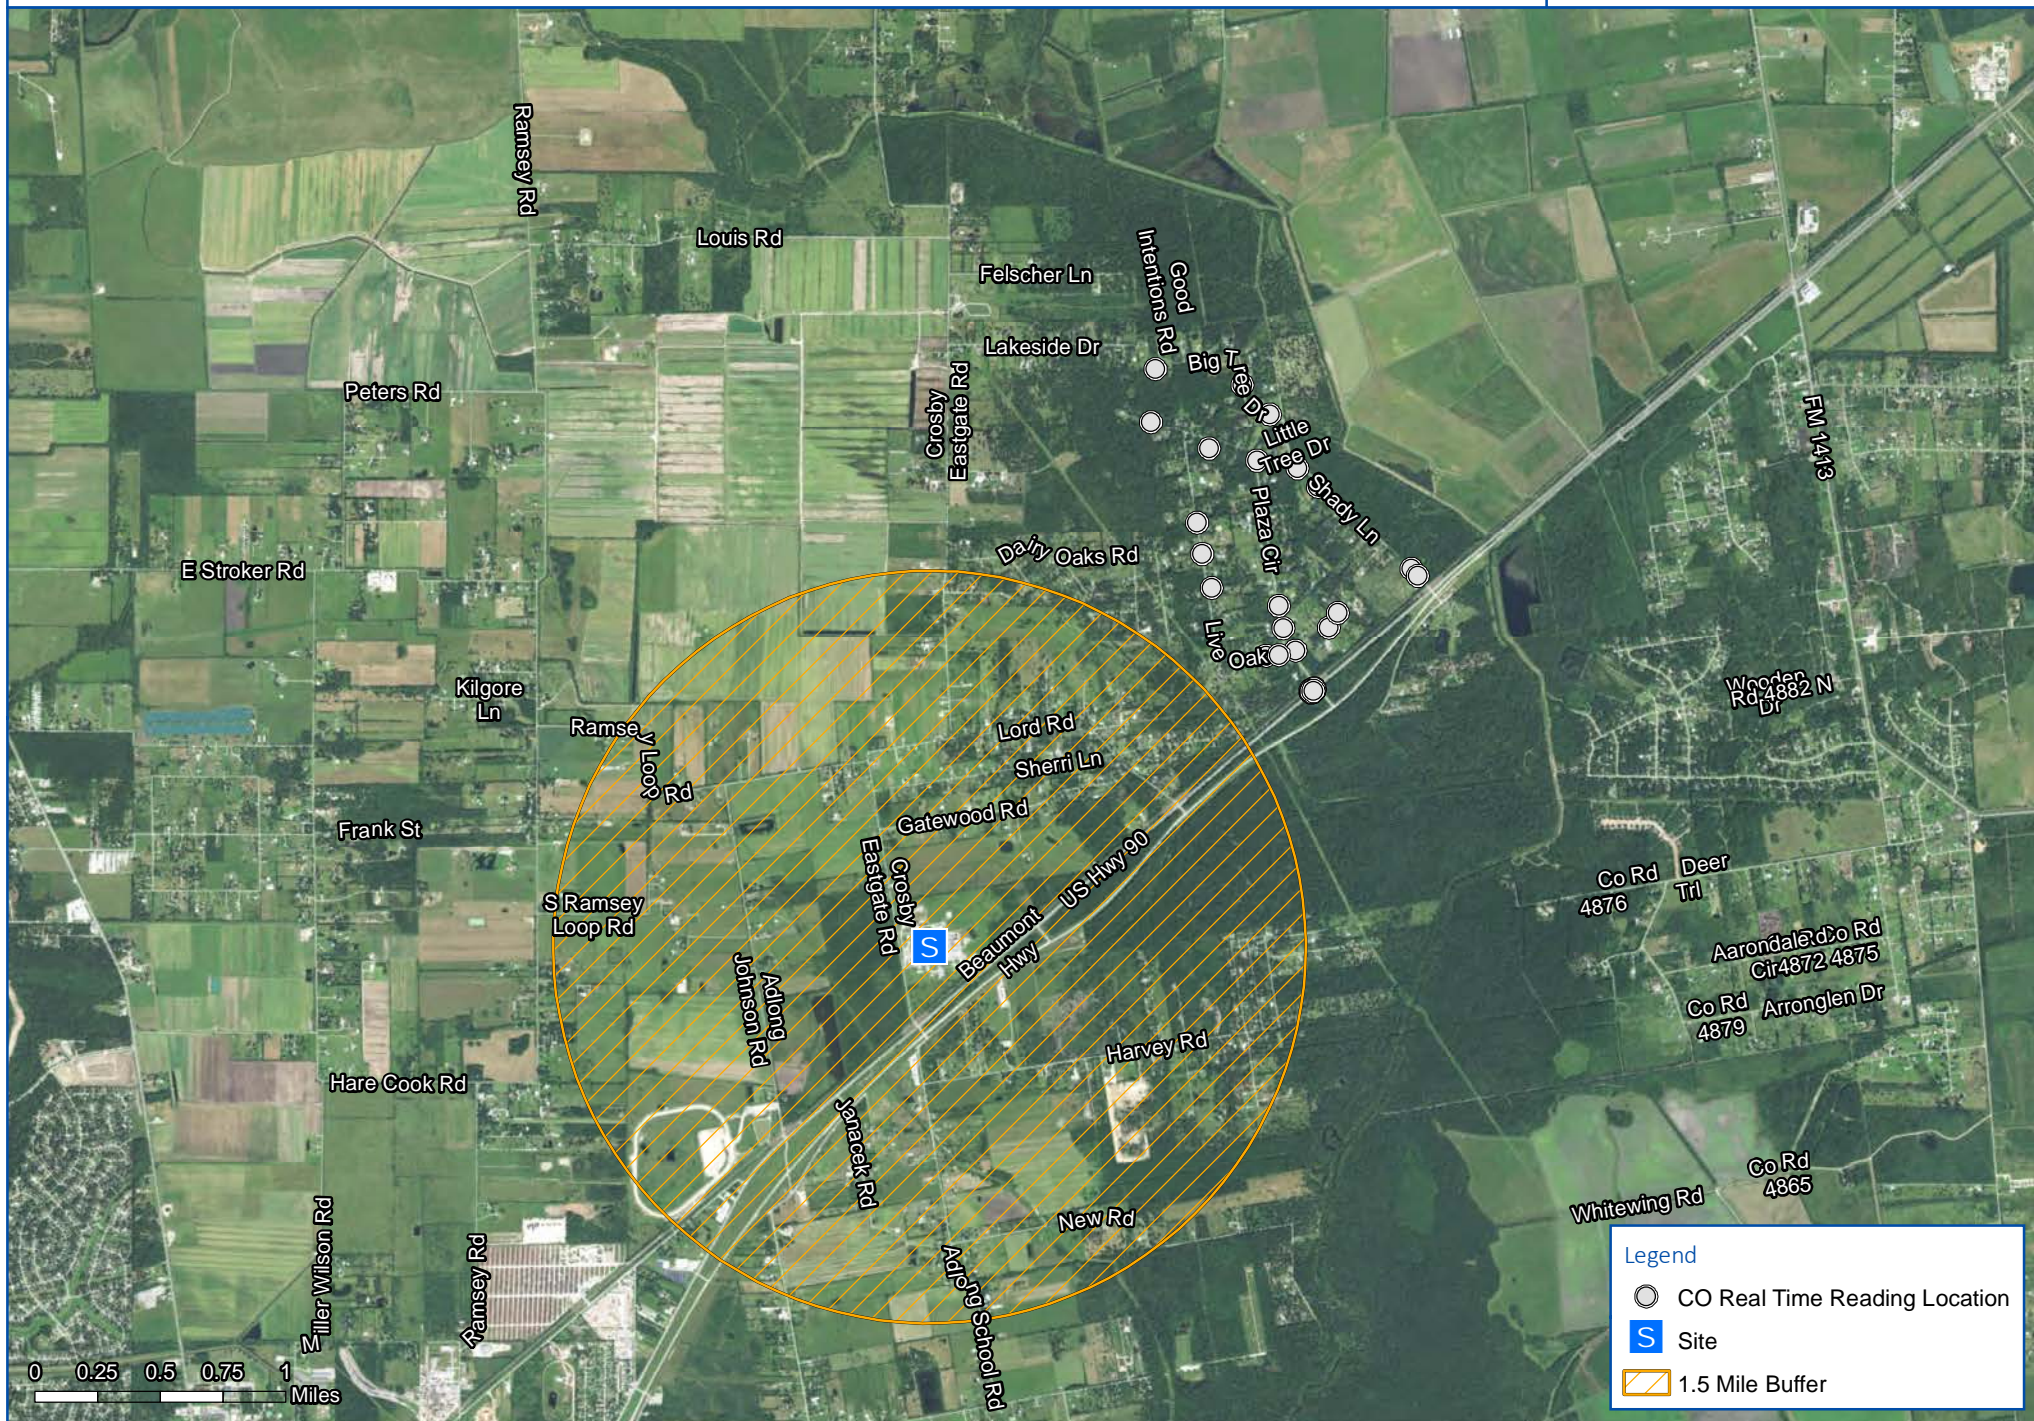
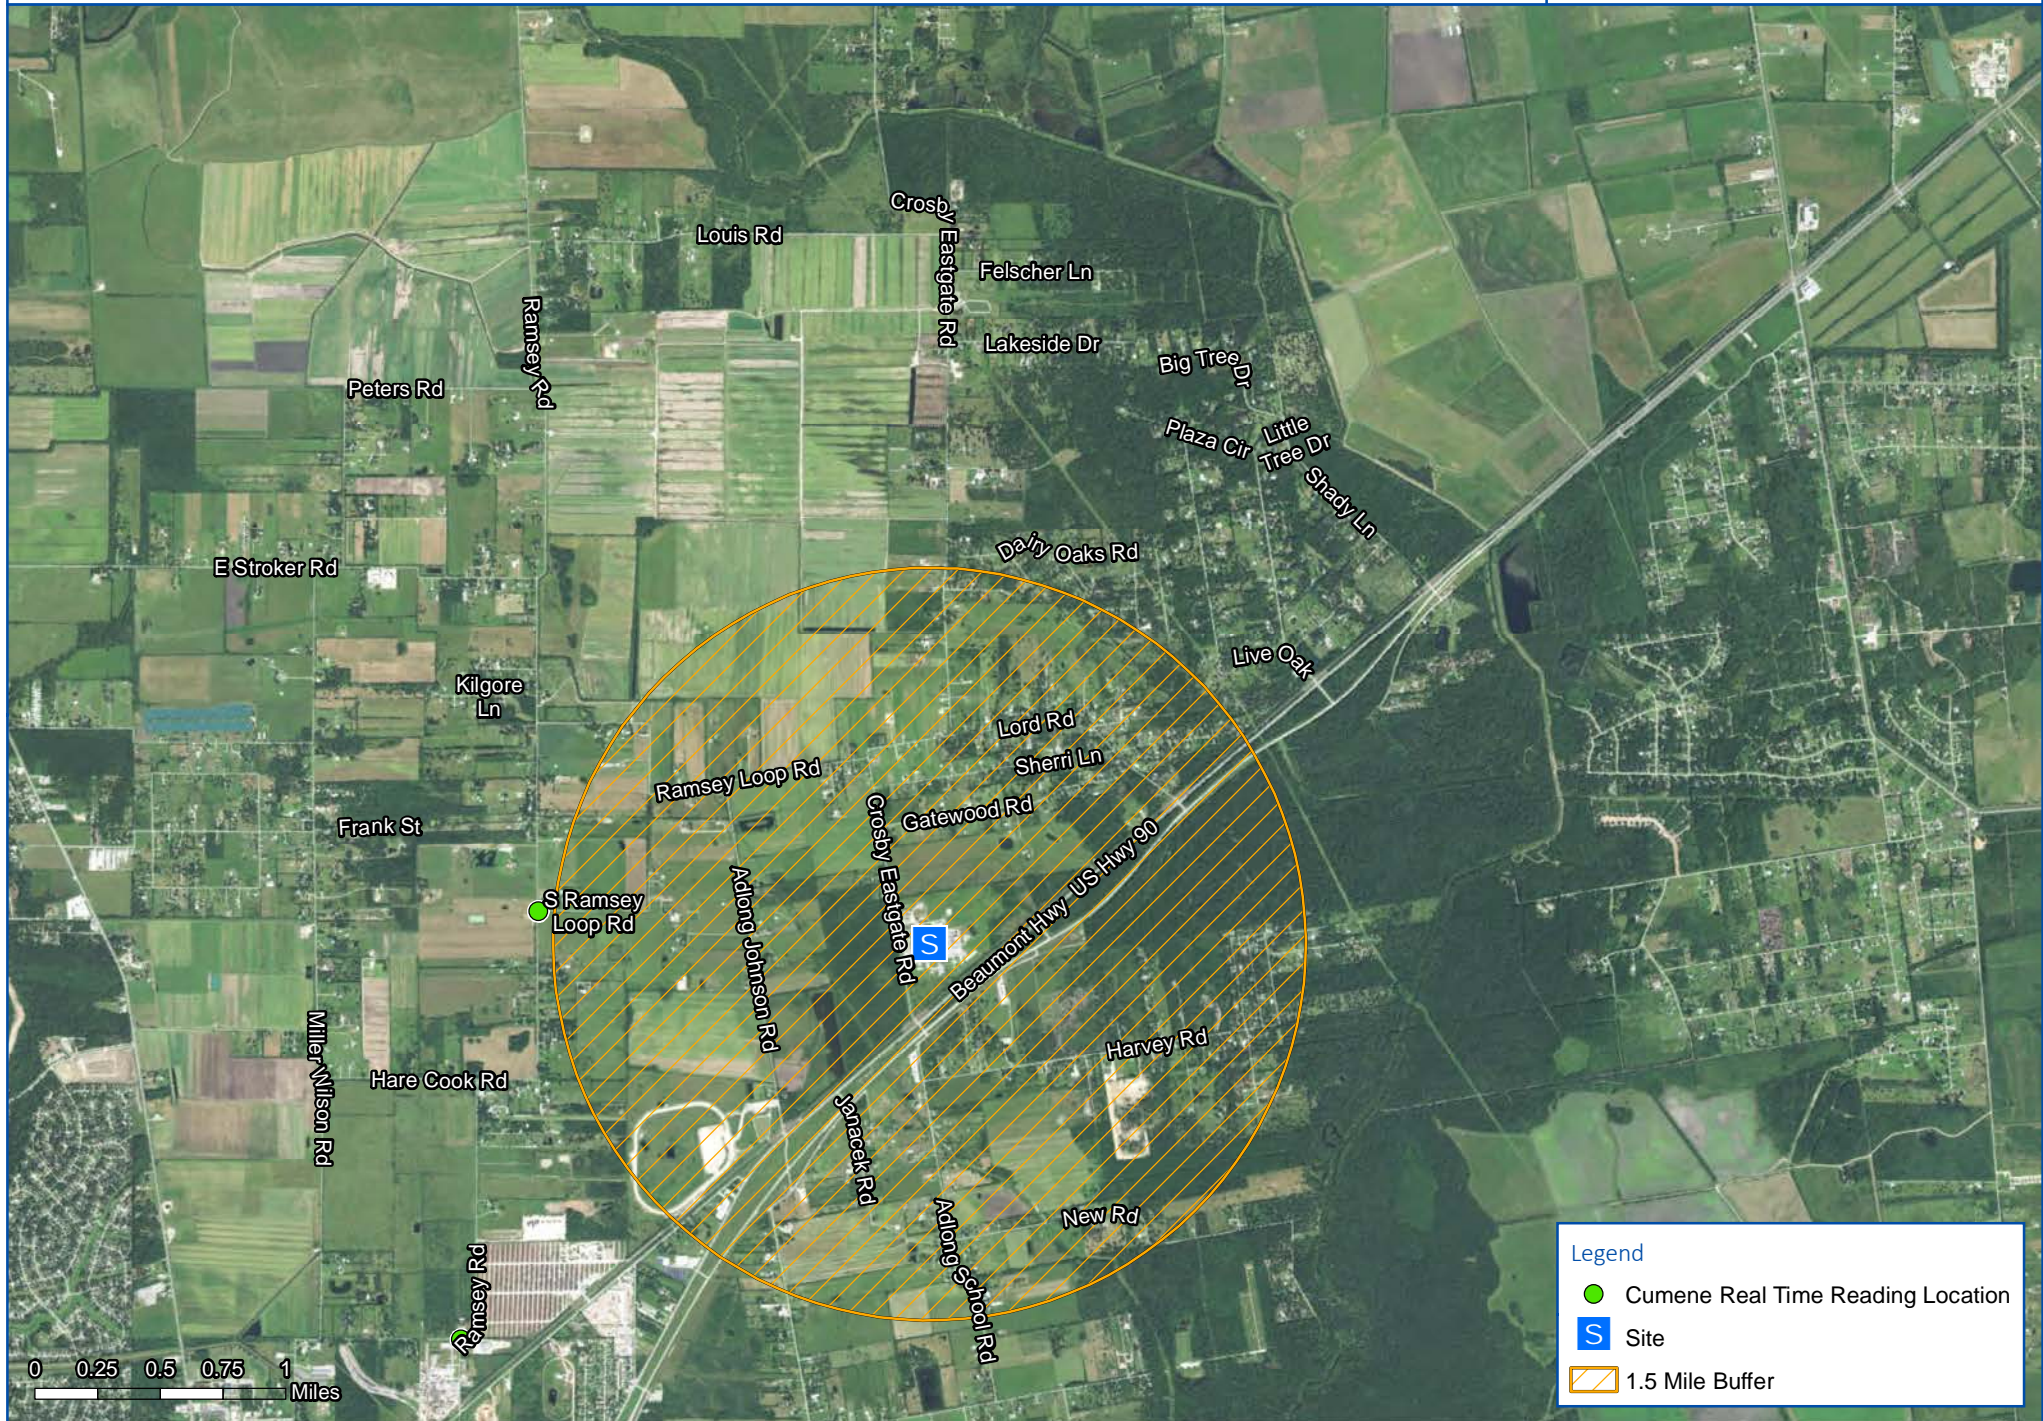
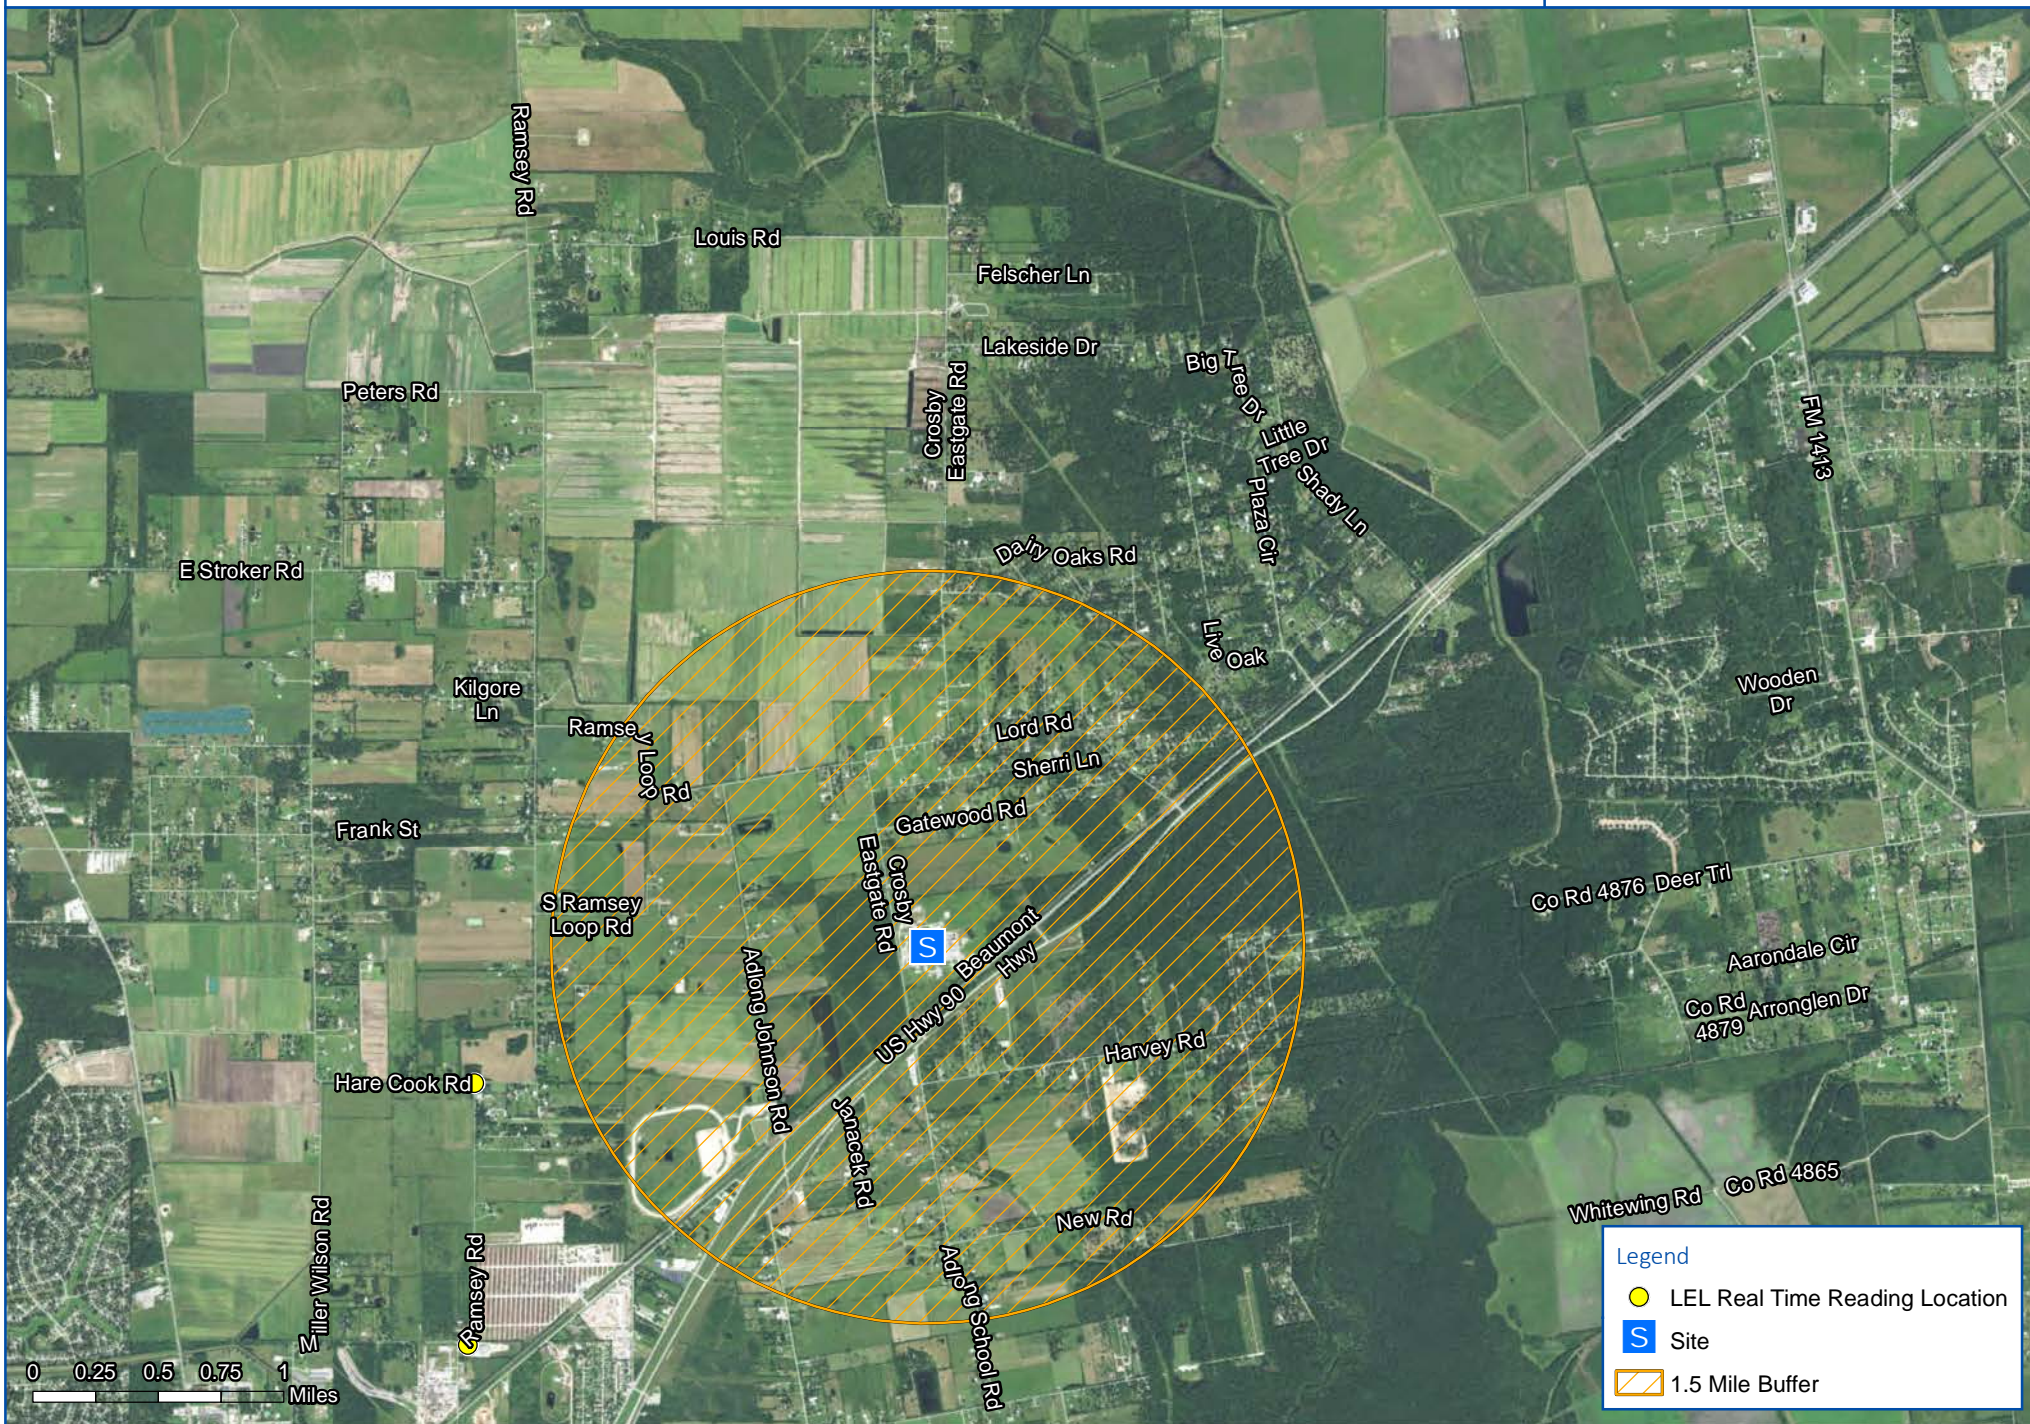
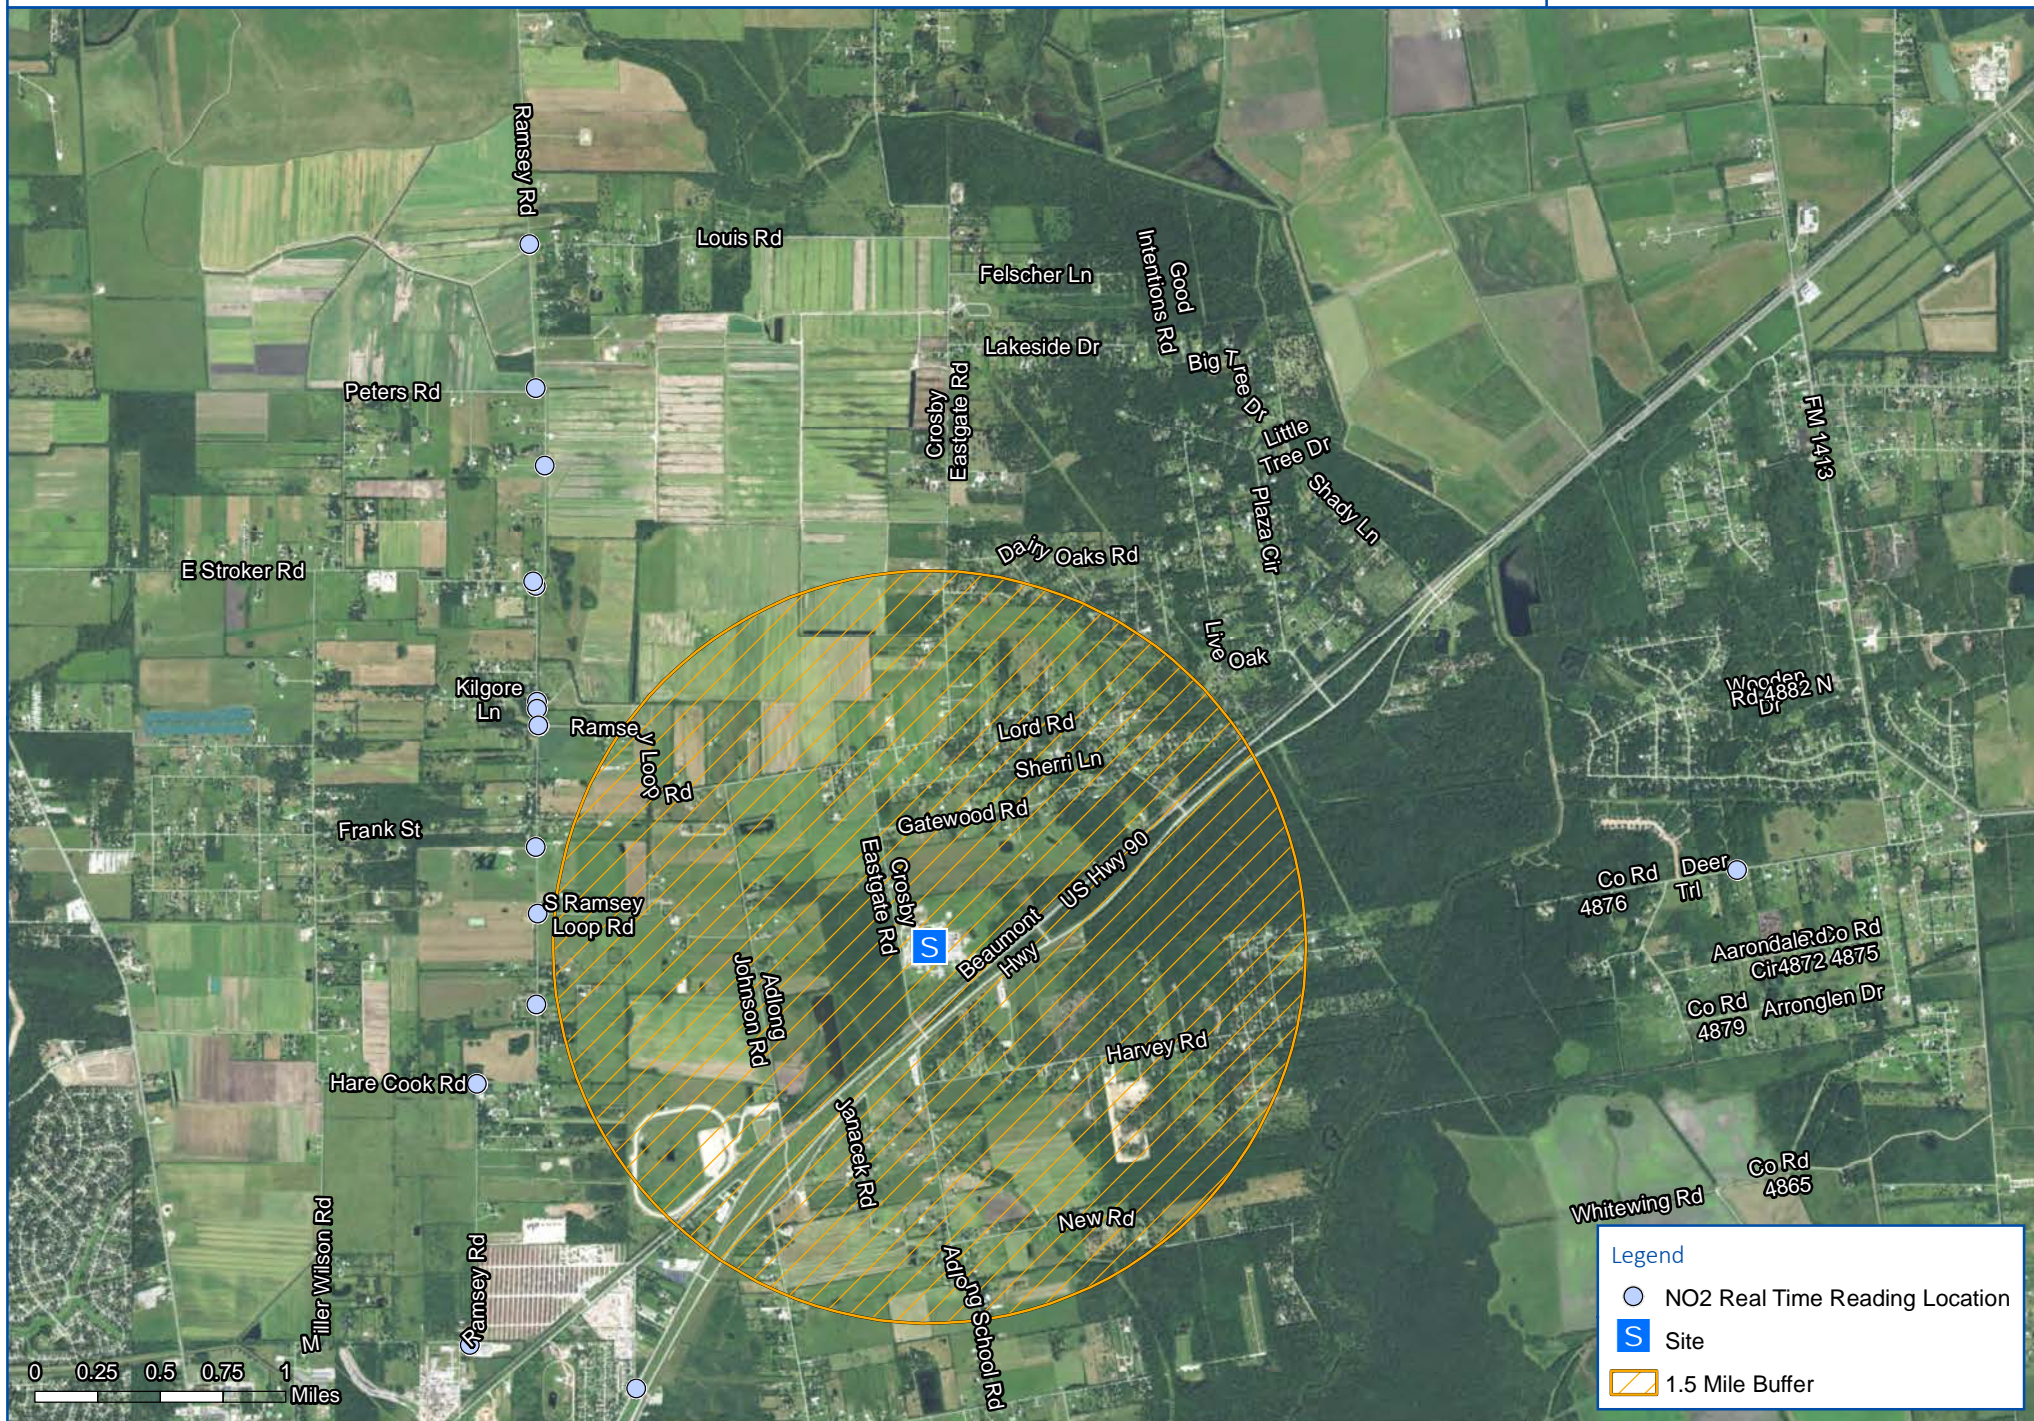
## **Handheld Real-time Air Monitoring Locations**

All real-time air monitoring instrumentation was calibrated per the manufacturer's recommendations prior to air monitoring. Handheld, real-time air monitoring was conducted for benzene, cumene, atmosphere flammability (lower explosive limit - LEL), and volatile organic compounds (VOCs) using RAE Systems and Gastec instruments. Additionally, combustion byproducts potentially associated with fire smoke, such as particulate matter (PM<sub>2.5</sub>), nitrogen dioxide (NO<sub>2</sub>) and sulfur dioxide (SO<sub>2</sub>) were assessed. **Table 1** summarizes the data for all real-time air monitoring readings recorded in Crosby, TX from 06:00 on September 1, 2017 through 06:00 on September 2, 2017. Maps of real-time air monitoring locations are provided as **Attachment B**.

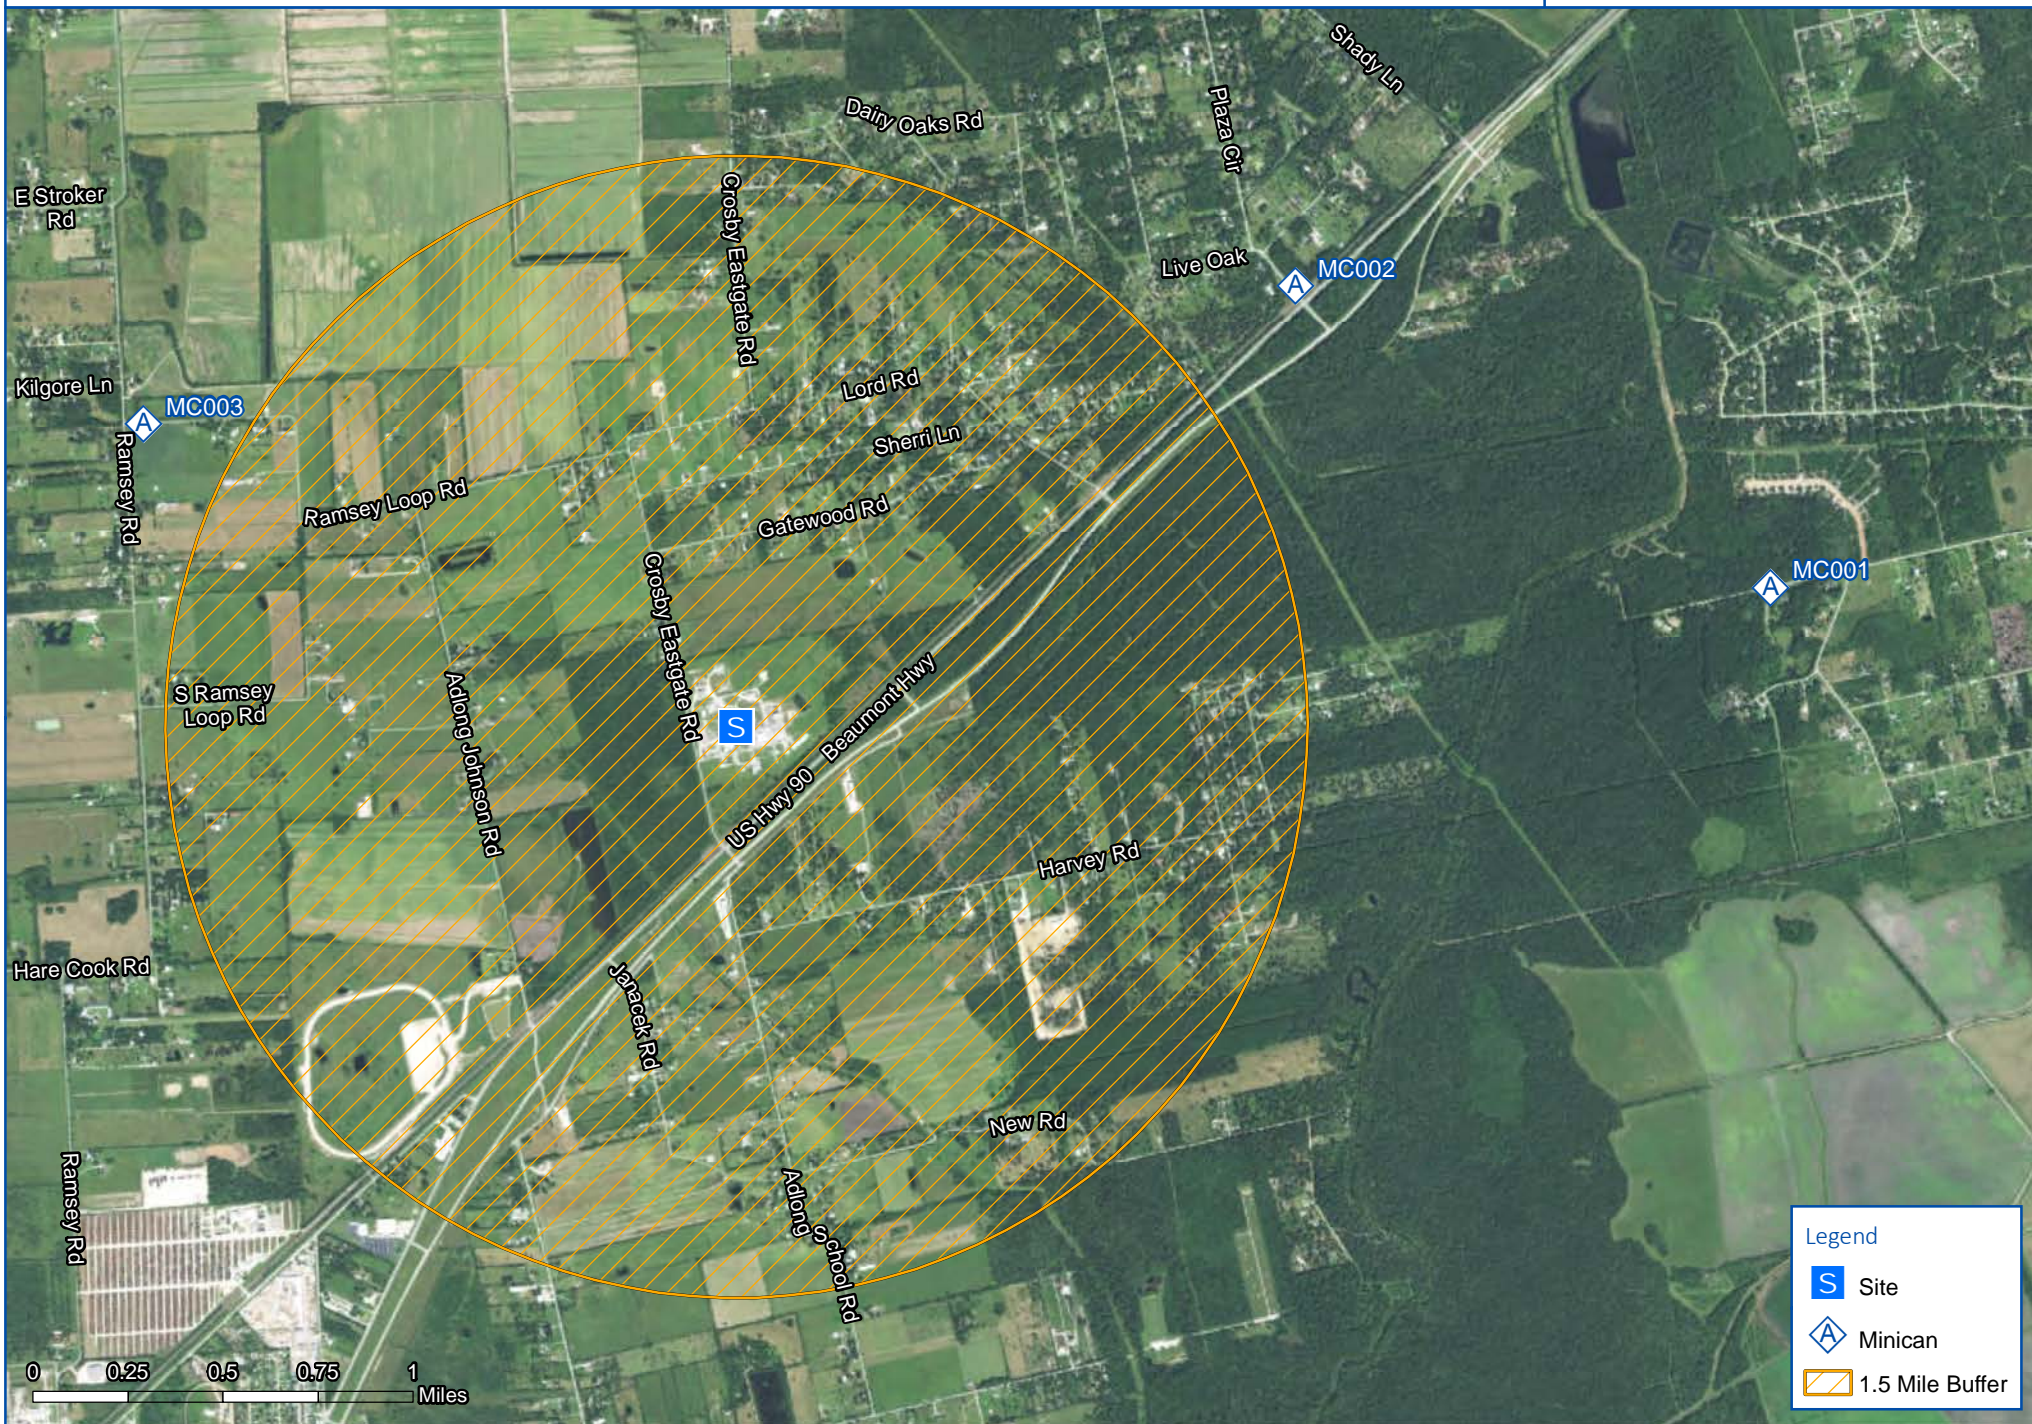
### **Map of Analytical Air Sampling Locations**

To supplement real-time air monitoring, CTEH® deployed areas along the perimeter of the evacuated area within the community. Evacuated canister (Minican™) samplers were regulated to collect air evenly over a 24-hr period. Analytical air samples will be submitted to SGS Galson Laboratories, an AIHA-accredited laboratory, for analysis using EPA Method TO-15. A map highlighting the analytical air sampling locations is provided as **Attachment C**. Analytical Air Sampling Results will be reported upon receipt from the laboratory.

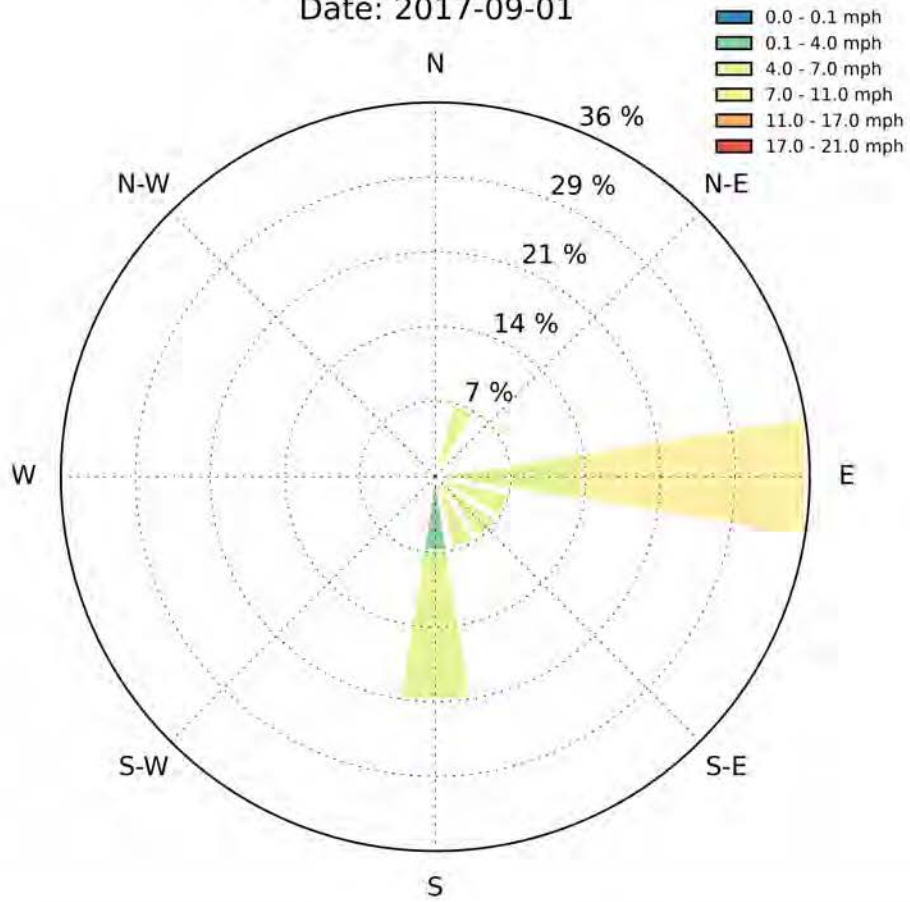
## **KHPY Windrose**

**(Highland Park Airport - 12.5 miles SSE of Site)**

Weather Station: KHPY  
Date: 2017-09-01
